Cold Asphalt Concrete Overlay

COLD ASPHALT CONCRETE OVERLAY

INTERIM REPORT

CA-HY-MR-3542-1-72-48

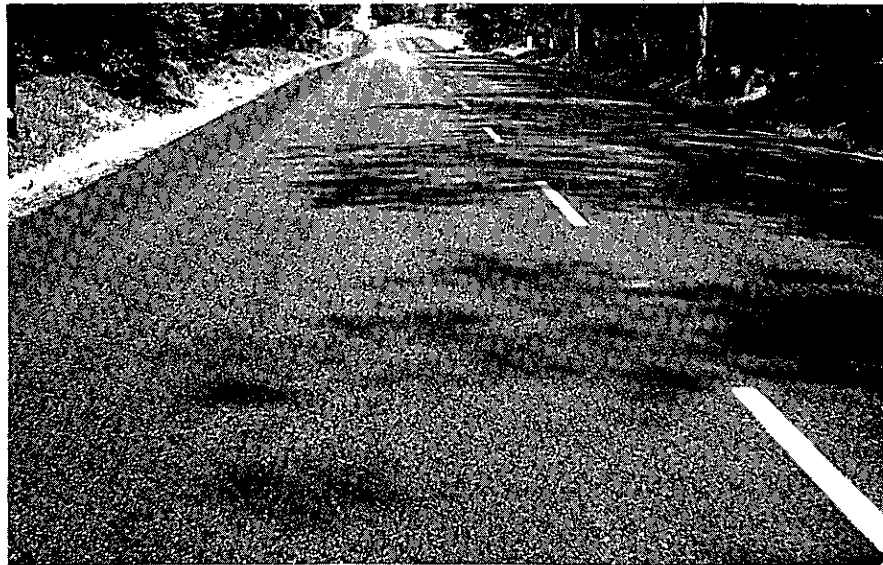
Figure 21 - Overall View of Dense Graded Cold Mix Looking East From Station 26+00

appearance (Figure 21). Traffic seemed to have smoothed out

the effects of raveling caused by the original fog seal though some signs still appear and in some areas there is evidence of the longitudinal construction joint (Figure 22). The unsealed area had continued to deteriorate and was definitely in

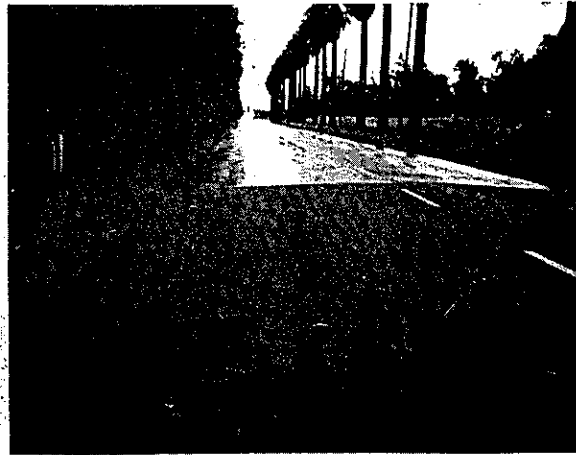
Figure 23 - Contrast During Rain of Hot Mix Dense in Background, and Cold Mix Open Graded Surfaces.

The open graded mix not only has good skid resistance, but also has excellent surface drainage characteristics. This is illustrated in Figure 23 which shows that comparison between

the open graded surface and the abutting hot mix dense graded surface during a rainstorm. Figure 24 shows the comparison between the cold mixed dense graded and the cold mixed open graded during the same rainstorm.

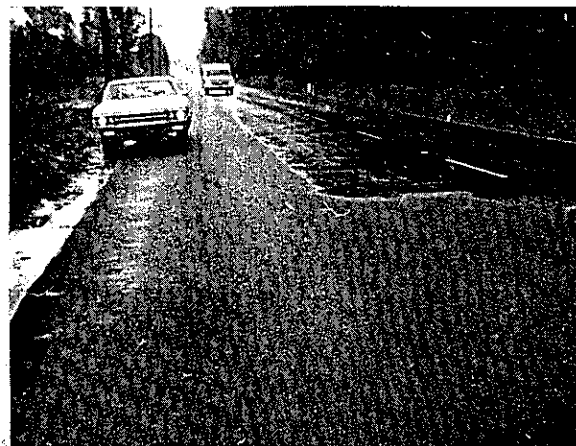
Figure 24 - Contrast During Rain of Dense (Right-Side), and Open Graded Cold Mix Surfaces.

It is evident that the open graded mix has good potential as a skid resistance treatment with excellent drainage characteristics. It is assumed that the application of a fog seal to reduce cracking and raveling would not materially reduce skid resistance.

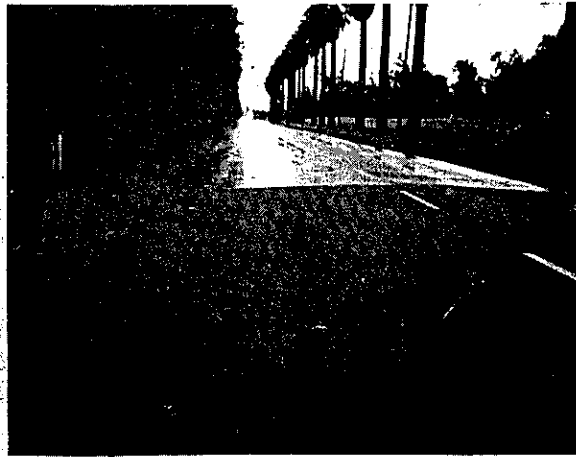
Figure 23 - Contrast During Rain of Hot Mix Dense in Background, and Cold Mix Open Graded Surfaces.

The open graded mix not only has good skid resistance, but also has excellent surface drainage characteristics. This is illustrated in Figure 23 which shows that comparison between

the open graded surface and the abutting hot mix dense graded surface during a rainstorm. Figure 24 shows the comparison between the cold mixed dense graded and the cold mixed open graded during the same rainstorm.

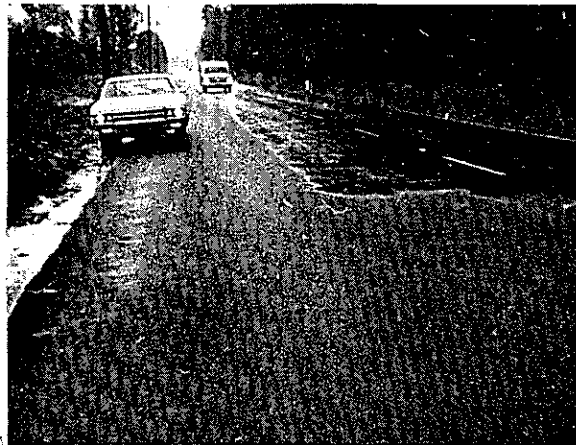
Figure 24 - Contrast During Rain of Dense (Right-Side), and Open Graded Cold Mix Surfaces.

It is evident that the open graded mix has good potential as a skid resistance treatment with excellent drainage characteristics. It is assumed that the application of a fog seal to reduce cracking and raveling would not materially reduce skid resistance.
